PHOTOGRAPHIC INTERPRETATION REPORT

ENEMY ROAD STATUS
LAOS PANHANDLE

AUGUST 1969

NPIC/R-89/69
OCTOBER 1969

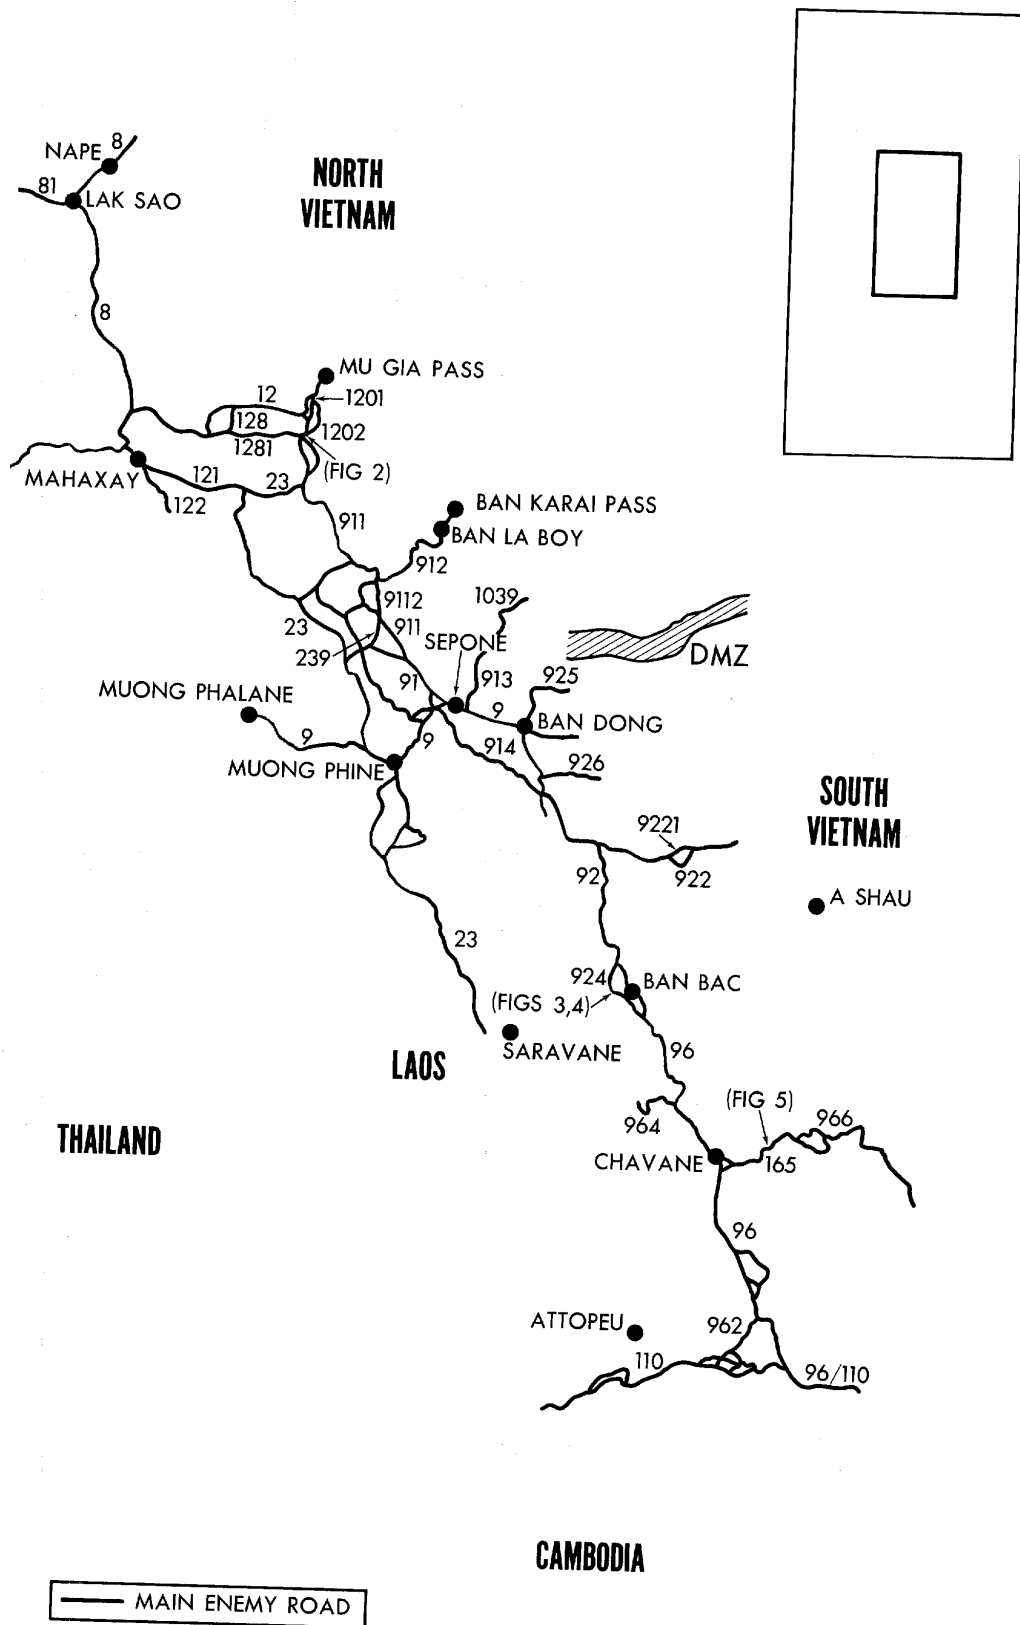
FIGURE 1. ENEMY ROAD NETWORK, LAOS PANHANDLE

All the major enemy-controlled roads in the Laos Panhandle are unserviceable or in disuse for the first time since this road net was completed (Figure 1). Damaging monsoon rains and heavy bombing raids have forced the closing of even the so-called "all-weather capability" roads on the network known as the Ho Chi Minh Trail.

The general condition of the Panhandle roads is very poor although a few routes such as 8, 239, and 911 north of 912 have a limited number of interdicted points and these can easily be repaired. Routes in extremely poor condition include the Mu Gia Pass roads (12, 1201, and 1202), the segment of 96 between Ban Bac and 964, all of Route 964, and the eastern two-thirds of Routes 912, 922, and 165/966.

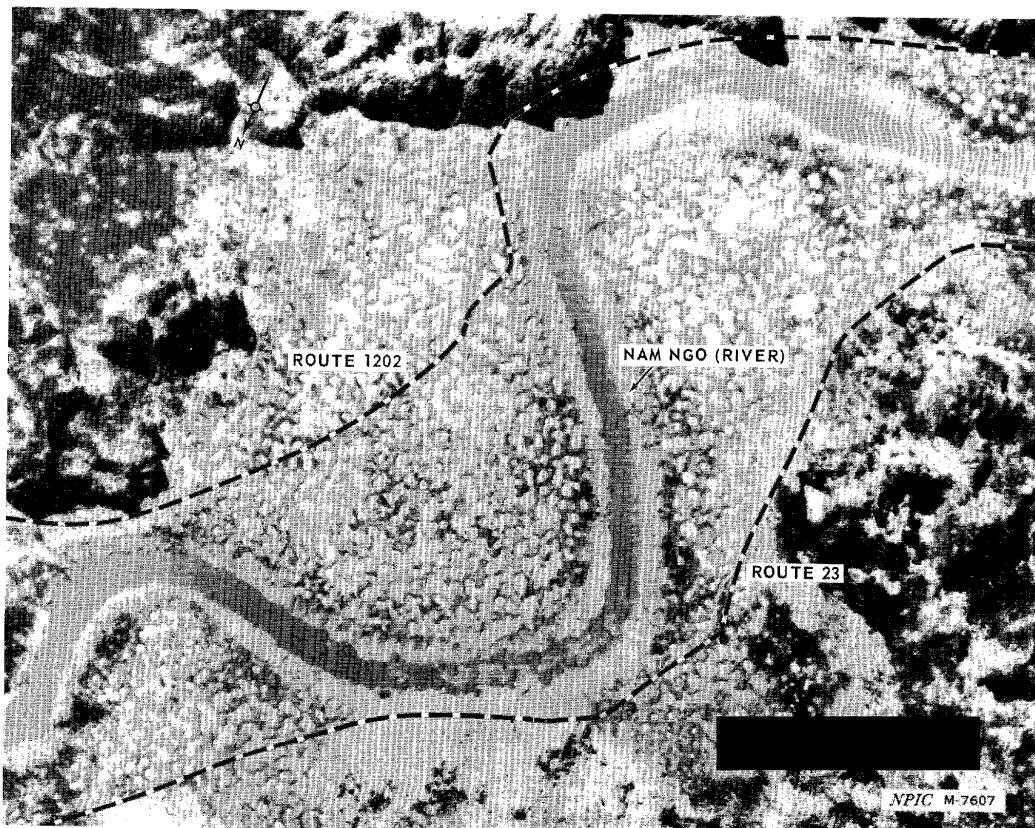
1201 and 1202 - These Mu Gia by-pass roads are interdicted in several places. The southern segment of 1202 has occasionally been under water (Figure 2).

FIGURE 2. INTERDICTION POINT SOUTH OF MU GIA PASS

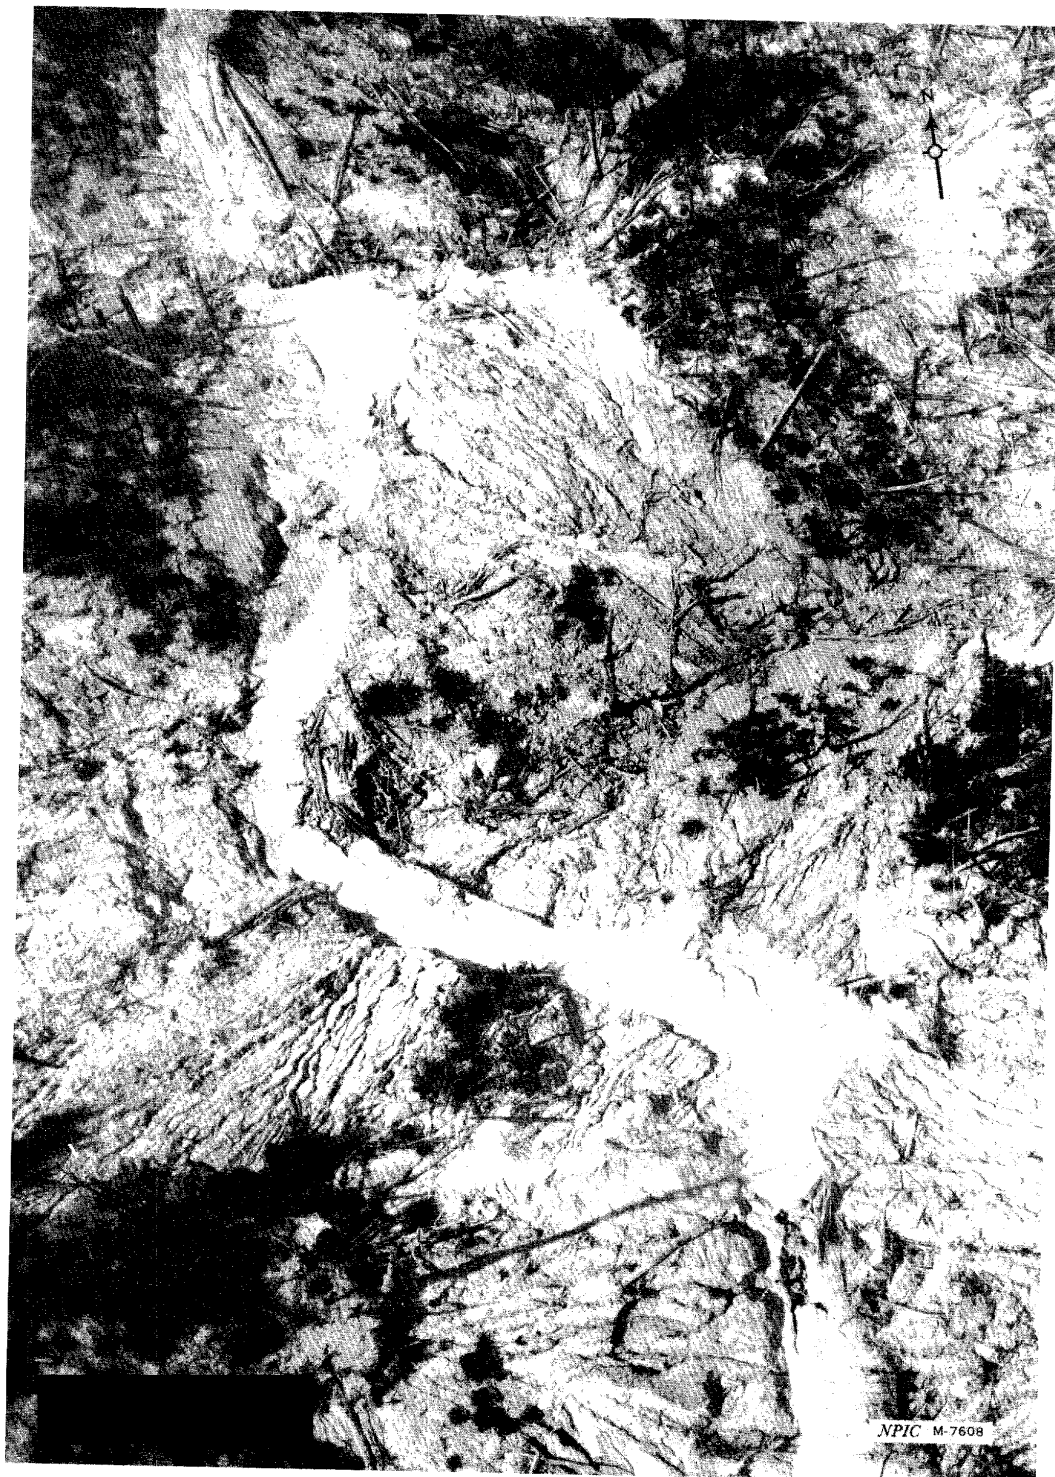
924 - This short road, similar to the adjacent segment on Route 92, is in very poor condition and several major landslides are observed (Figures 3 and 4).

FIGURE 3. WASHOUT DAMAGE, ROUTE 924, BAN BAC, LAOS

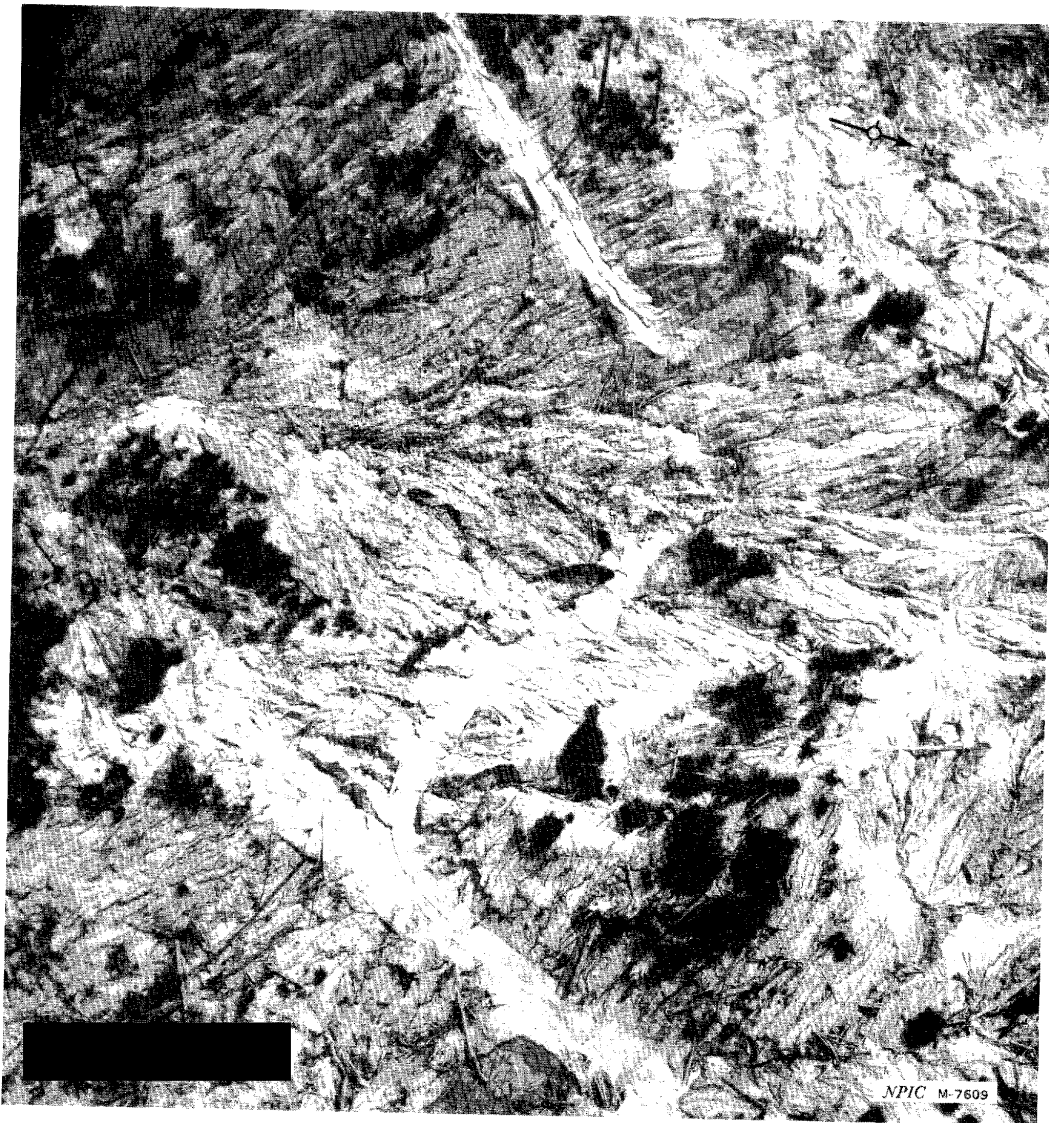
FIGURE 4. LANDSLIDE DAMAGE, ROUTE 924, BAN BAC, LAOS

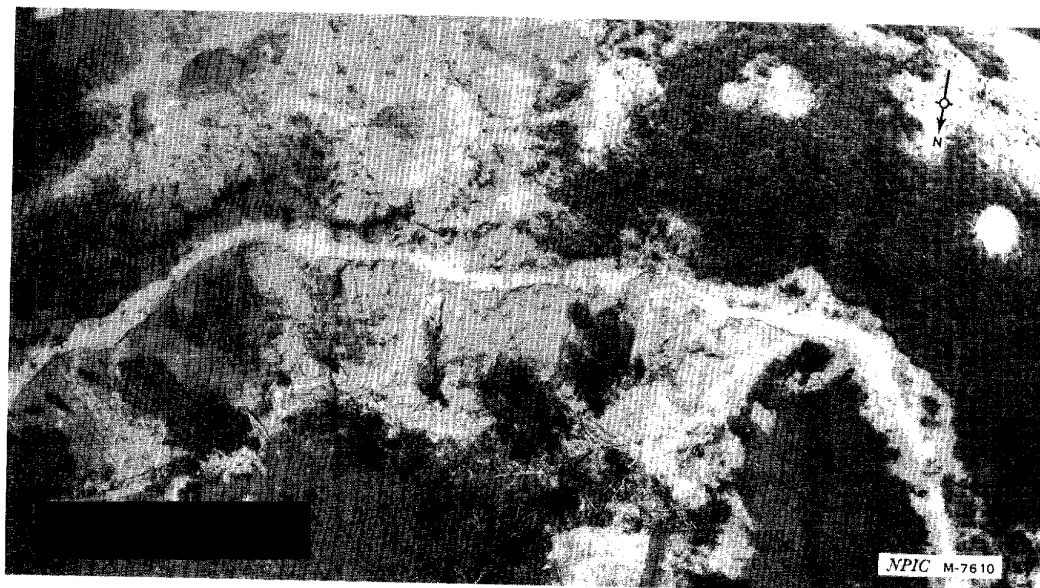
165 and 966 - The western two-thirds of this road appeared serviceable, but was sustaining little, if any, use where intermittently observed early in the reporting period. Lat-

er, however, this segment was interdicted in several places, as is the segment east of Chavane (Figure 5).

FIGURE 5. DETERIORATED ROAD, ROUTE 165, LAOS
